Firmware Version: v1.28.009
Prom Code Version: v1.00.007
Published: Jun 13, 2011

These release notes include important information about D-Link switch firmware revisions. Please verify that these release notes are correct for your switch:

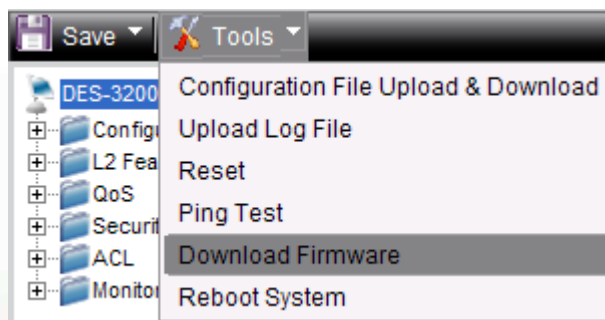
1. Connect a workstation installed with java SE runtime environment to any switch port of the device.
2. Open the web browser from the workstation and enter the IP address of the switch. The switch's default IP address is 10.90.90.90.
3. Enter administrator's username and password when prompted. It should be noted that the username and password are blank by default.
4. To update switch's firmware or configuration file, select **Tools > Download Firmware** from the banner.

5. Enter the TFTP Server IP address.
6. Enter the name of the firmware file located on the TFTP server.
7. Select the Image ID you would like to store the firmware file.
8. Click "**Download**" button.
9. Wait until the "File Transfer" status reaches 100% and the "Program Firmware" status shows "completed".
