Firmware Version: 1.10.005
Boot Code Version: 1.00.011
MIB Version: 1.00.008
D-View Module Version: 1.0.0.7
Published: Feb. 23, 2012

These release notes include important information about D-Link switch firmware revisions. Please verify that these release notes are correct for your switch:

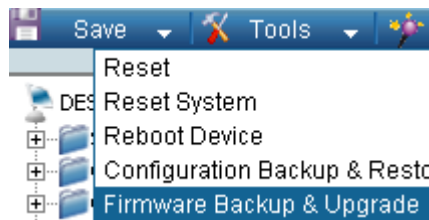
1. Connect a workstation installed with java SE runtime environment to any switch port of the device.
2. Open the web browser from the workstation and enter the IP address of the switch. The switch's default IP address is 10.90.90.90.
3. Enter administrator's password when prompted. The password is **admin** by default.
4. To update switch's firmware or configuration file, select **Tools > Firmware Backup & Upgrade** from the banner.

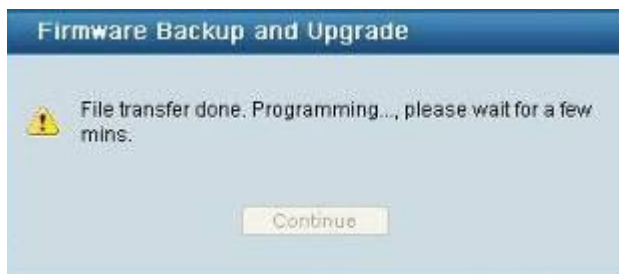
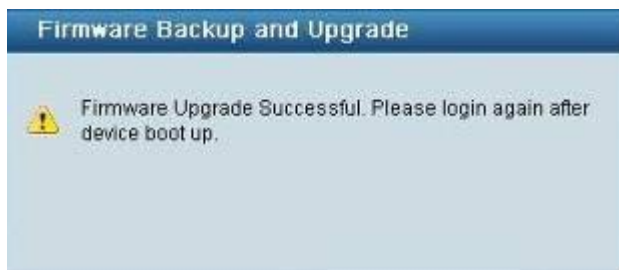
e. Wait until the "Firmware Upgrade Successful" message pops up and login again after device boots up.

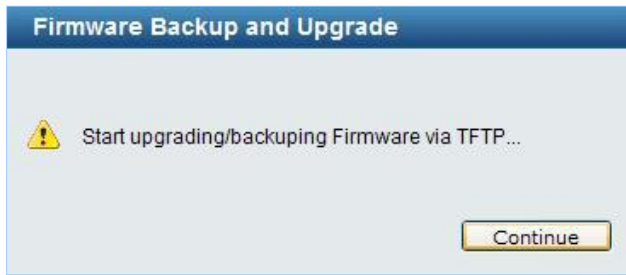
d. Wait until the firmware upgrade ends and login again after device boots up.
