**Firmware Version:** V1.01.023

**OS Version:** V1.1.8

**Published:** 2021/06/10

These release notes include important information about D-Link DXS-3610 Series firmware revisions. Please verify that these release notes are correct for your switch:

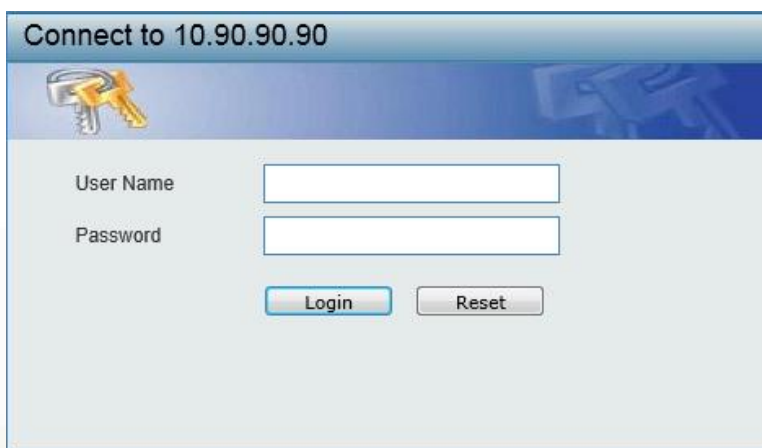
3. A user authentication window will be opened, by default, there is no user name and password configured on the switch. Just leave the **User Name** and **Password** fields blank and click the Login button.
